# What a Roof Inspection in Newport Beach Should Include

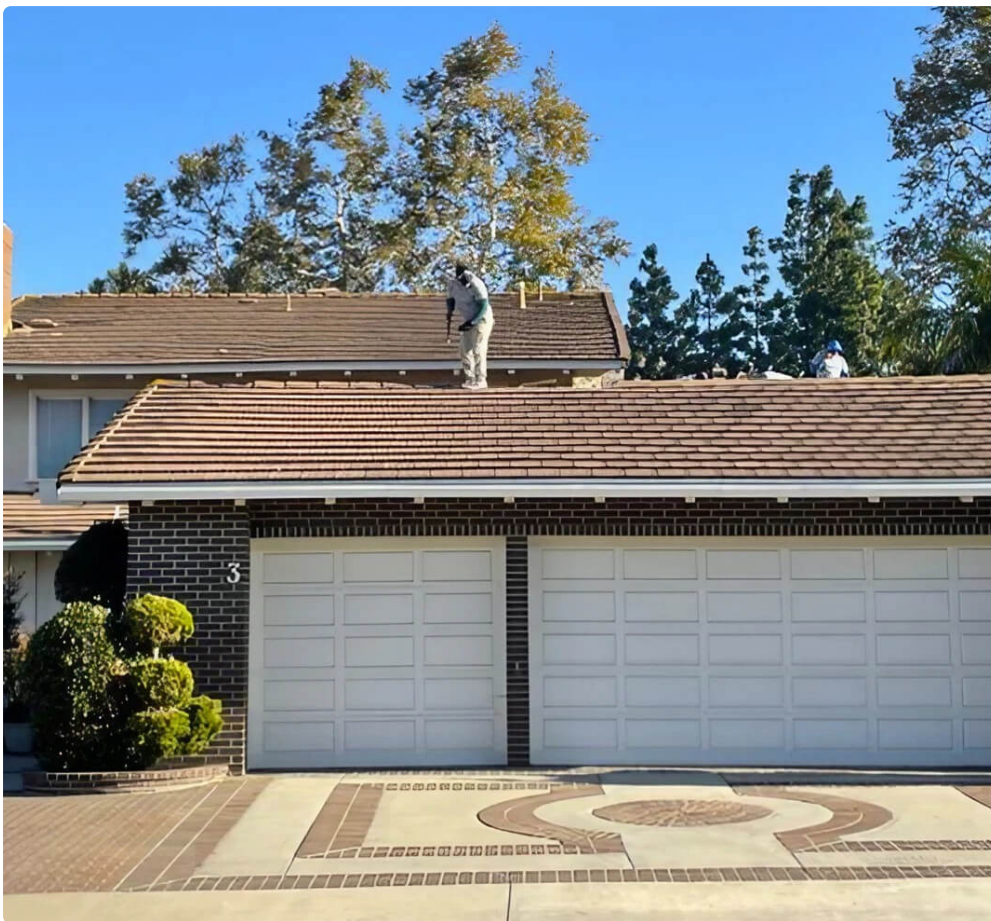
On tile roofs, the inspection should track cracked tiles, slipped tiles, loose ridge material, broken bird stops where applicable, and movement around valleys. Just as important, it should identify signs that suggest underlayment failure rather than surface tile damage alone. Staining at overlaps, patch clusters in the same roof section, or leaks near penetrations often point below the tile.
